Facility Condition Assessment & Space Study Project KRS 164 / M-05468008

Final Report

Kentucky Postsecondary Education System University of Kentucky Facility Condition Assessment & Space Study

University of Kentucky

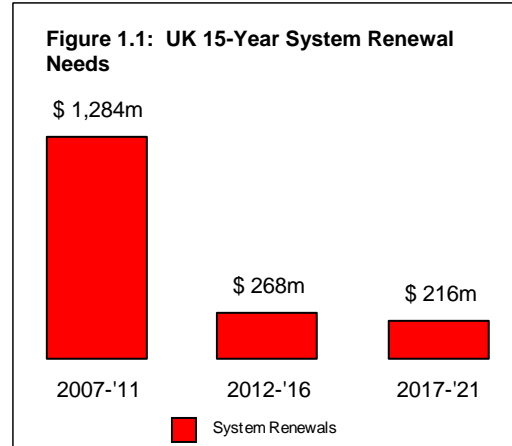
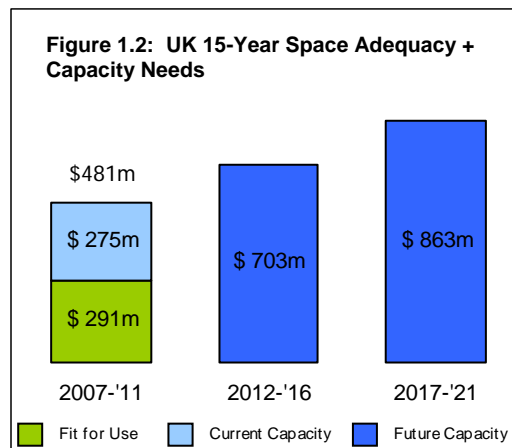
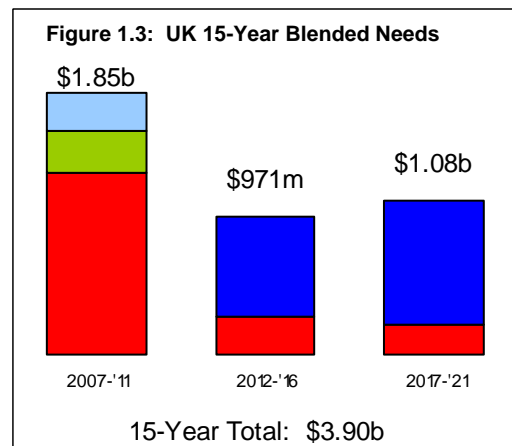
Summary of Findings Figures:

LEGEND: Colors in Figure 1.3 correspond to labels in Figures 1.1 & 1.2. Figure 1.3 summarizes the annual needs presented in Figure 6.4.

- For facilities included in the study, the total 15-year capital investment required to address condition, adequacy and capacity is \$3.9 billion. (Figure 1.3 and Section 6.)

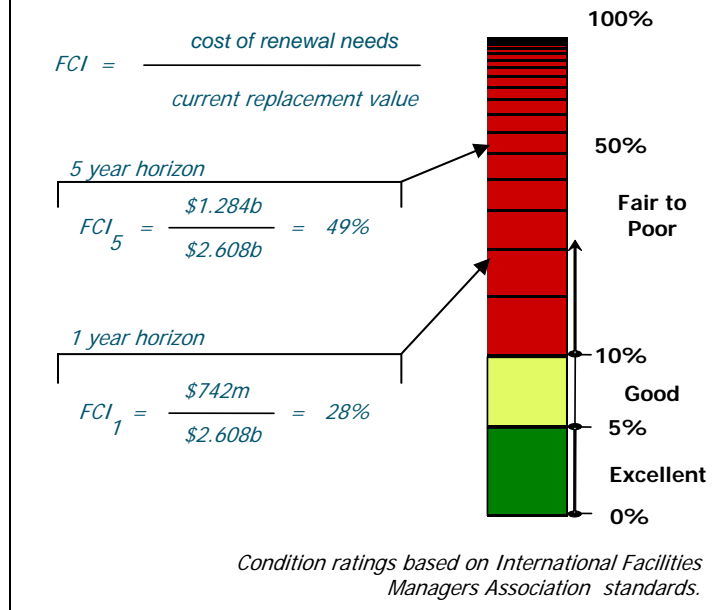
Figure 4.1: University of Kentucky Facility Condition Index

The facilities assessed have a current replacement value of \$2.608 billion, so the Facility Condition Index (cost of renewals, divided by current replacement cost) for the portfolio is 28% for a 1-year horizon, and 49% for a 5-year horizon. Based on International Facility Managers Association standards, both the 1-year and 5-year FCIs would be considered "fair" to "poor" rankings.

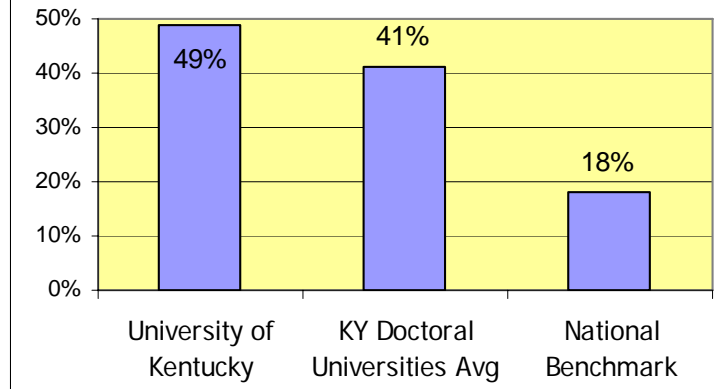
Figure 4.2 UK 5-Year FCI Comparison

Compared to other higher education portfolios evaluated by the consultants' team over the past 5 years, UK's is in worse condition (49% UK 5-year FCI vs. 18% benchmark 5-year FCI).
