# Facility Condition Assessment & Space Study Project KRS 164 / M-05468008

Final Report  
with costs updated to 2013 dollars

## Kentucky Postsecondary Education System Statewide Summary

# Kentucky Postsecondary Education System Facility Condition Assessment & Space Study

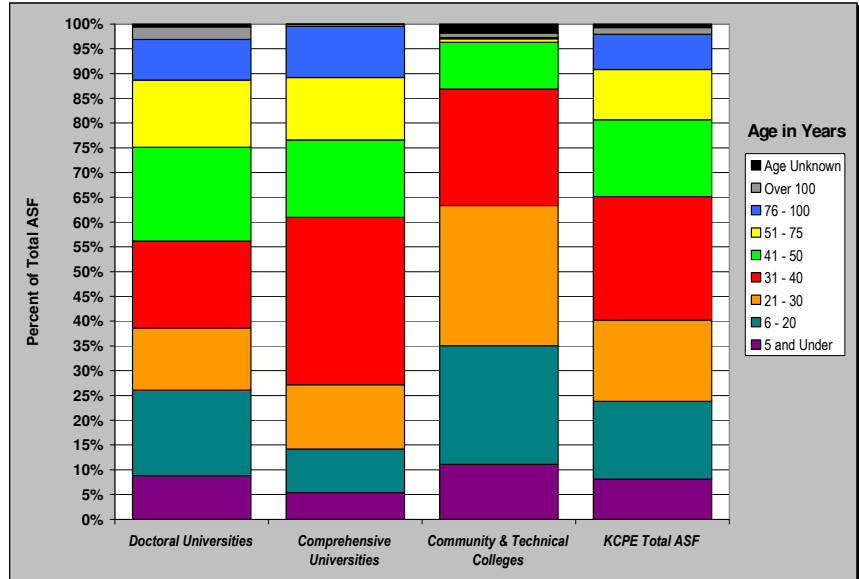
Approximately 35% of all E&G Kentucky postsecondary education system space is over 40 years old. The comprehensive universities have the least proportionate amount of new space with less than five percent (5%) of its space younger than five years old. Less than 15% of its space is 20 years or less compared to the doctoral universities which have slightly more than 25% of their space 20 years or less. Both the doctoral universities and the comprehensive universities have about 25% of their space in facilities 50 years and older. Less than five percent (5%) of the community and technical college space is over 50 years old.
